The Fracture Pattern of Different Mandibular Over-Denture Designs.

Ahmed M. Hussein
BDS, MSc (Assist Lect)

Department of Prosthetic Dentistry
College of Dentistry, University of Mosul

Hussein AM. The Fracture Pattern of Different Mandibular Over-Denture Designs. *Al-Rafidain Dent J*. 2008; 8 (1): 1-5 .

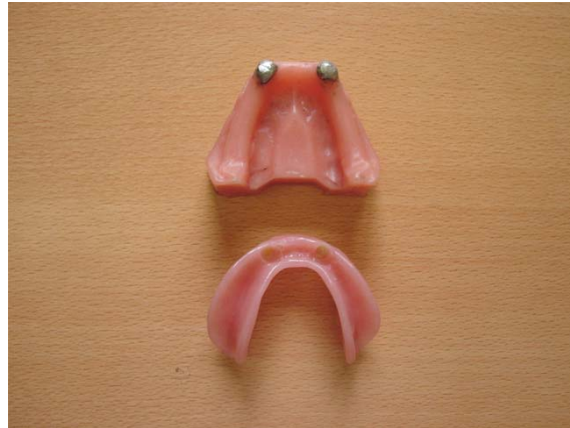
Two different over-denture designs were constructed in this study. The first design consisted of an acrylic resin over-denture supported by two dome-shaped copings of about 3 mm height, Figure (1). The second design consist of acrylic resin

Figure (1): The over-denture and the cast with two copings.

The fracture position which was determined visually revealed that the first design over–denture was fractured over one of the two abutment, and the fracture line extended obliquely from the labial flange beneath the lateral incisor or the central incisor, crossing over one of the abutments, to the lingual flange on the other side. This was agreed with Brewer and Morrow ⁽²⁾ and Langer and Langer ⁽³⁾.

This fracture position of the over–denture could be attributed to the fact that during displacement of the denture downward due to the compression of the underlying rubber base material, the two abutments will function like a fulcrum. This fact is added to another fact that the denture thickness is reduced over this area in comparison to other parts of the denture this become on line with Fatih–Elbaab ⁽²⁴⁾.

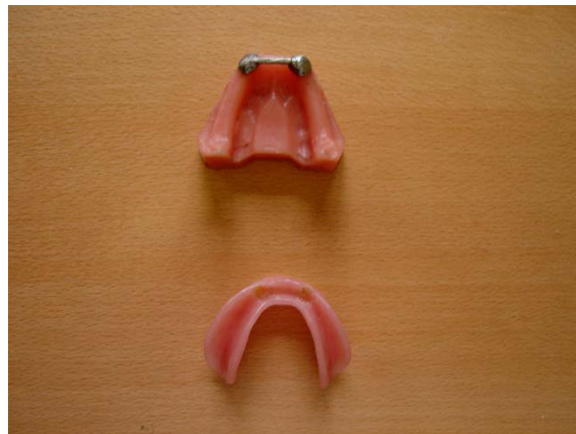
over-denture with two metallic copings that was connected with a metal bar of about 2 mm thickness and width, the bar was away from the residual ridge of about 1 mm, thus the total height of the bar and the copings was about 3 mm, Figure (2).

Figure (2): The mandibular over-denture and the cast with the two copings connected by the bar.

The fracture resistance of the second over–denture design was significantly lower than the fracture of the first design, this was due to firstly the space occupied by the metallic bar which decreases the thickness of the denture base, secondly the rigid bar attachment used, that provide no stress–breaking action, could induce excessive stresses in the overlying denture base during their displacement under load which in this case may act as a fulcrum initiating denture fracture.

The fracture position (which was noted visually) of the second over–denture design occur approximately at the midline of the lingual flange and the fracture line extended to the labial flange, crossing over the bar rather than over the abutments. In this case the explanation is usually directed to the presence of the bar as a fulcrum
